# Hazardous Building Material Survey

Lincoln Avenue and Manchester Avenue

Anaheim, California 92801

August 18, 2017 | Project No. 210248001

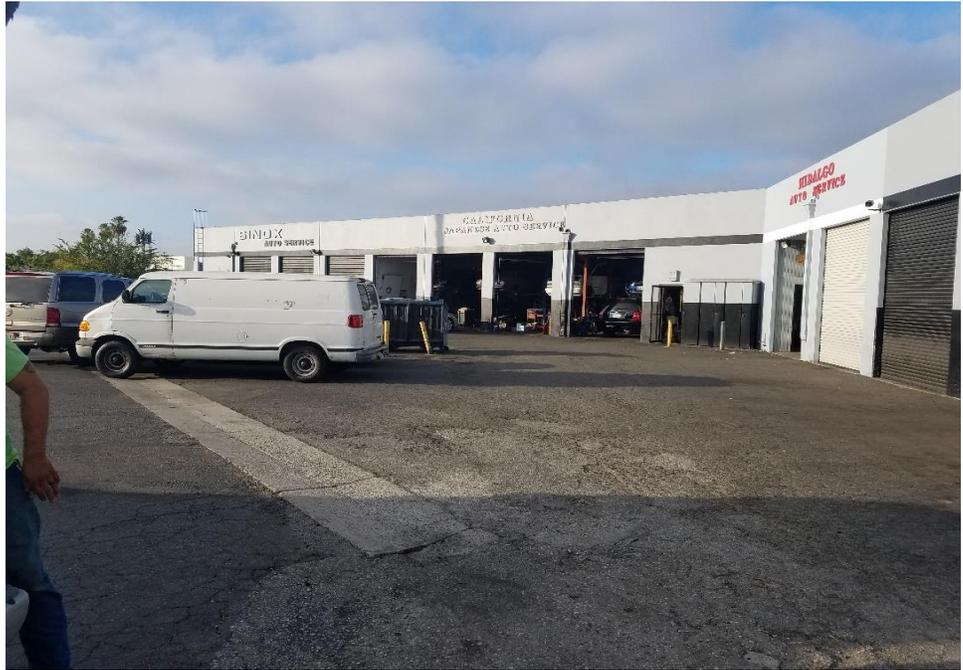
**Photograph 1:** General view of the site structure.

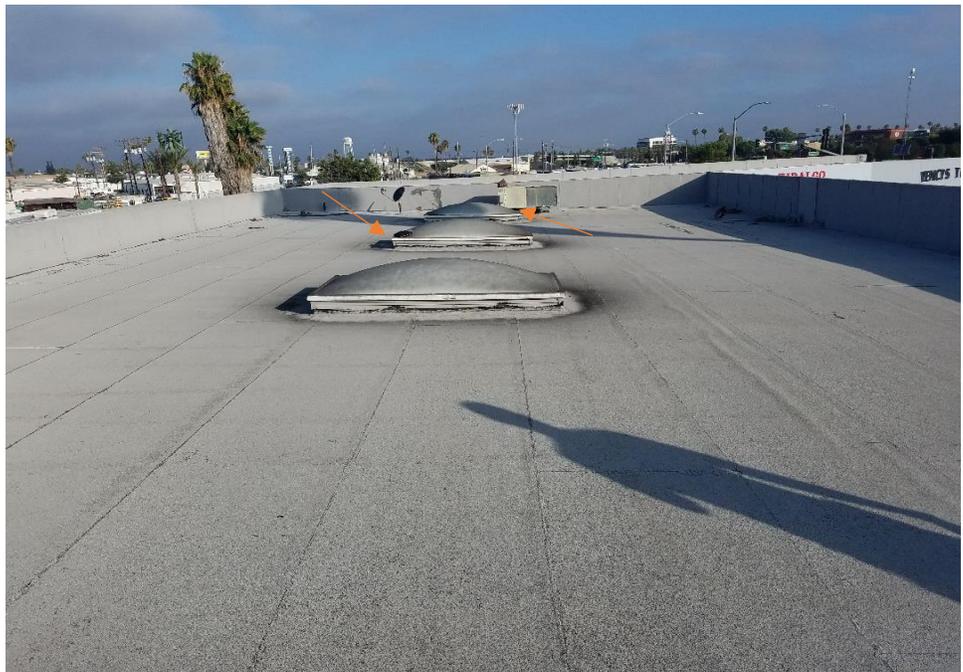
Material	Location	ACM Category	Condition	Approximate Quantity	Photograph No.
<b>Exterior</b>					
Penetration mastic	Roof	NESHAP Category II Non-friable	Good	30 SF ACM	2
Mastic at HVAC seams	Roof	NESHAP Category II Non-friable	Good	10 SF ACM	2
<b>1514 West Lincoln Avenue</b>					
NA					
<b>1516 West Lincoln Avenue</b>					
NA					
<b>1518 West Lincoln Avenue</b>					
Vinyl floor sheeting	Restroom	NESHAP Category II Non-friable	Good	25 SF ACM	3
Mastic associated with 1' x 1' gray vinyl floor tile	Offices	NESHAP Category II Non-friable	Good	200 SF ACM	4
<b>1520 West Lincoln Avenue</b>					
NA

**Photograph 2:** View of the asbestos containing penetration mastic and HVAC seam mastic.

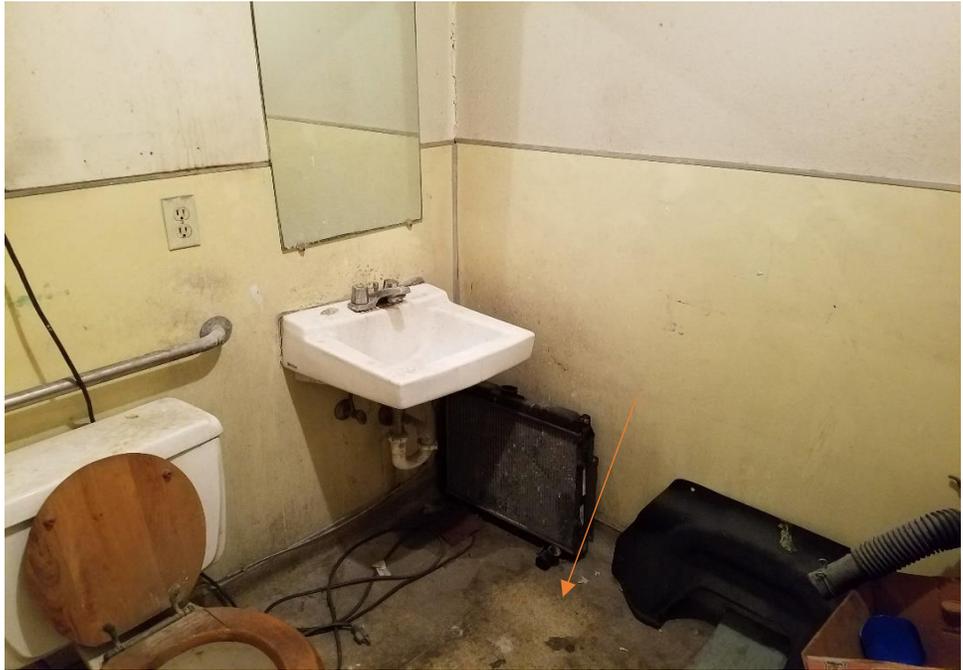
**Photograph 3:** View of the asbestos containing vinyl floor sheeting in Unit 1518 restroom.

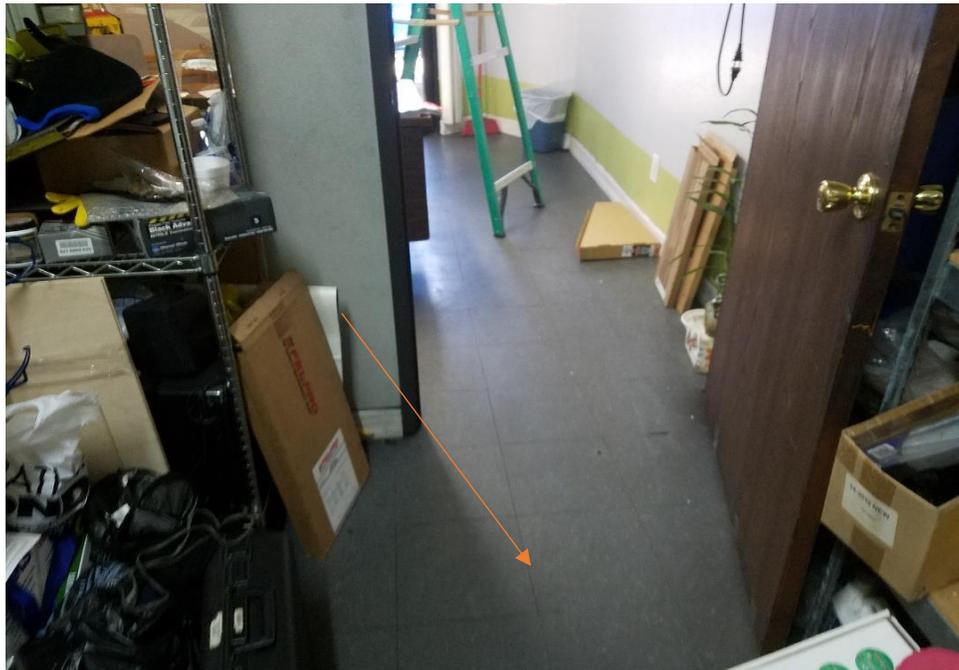
**Photograph 4:** View of the asbestos containing 1' x 1' gray vinyl floor tile and mastic in Unit 1518.

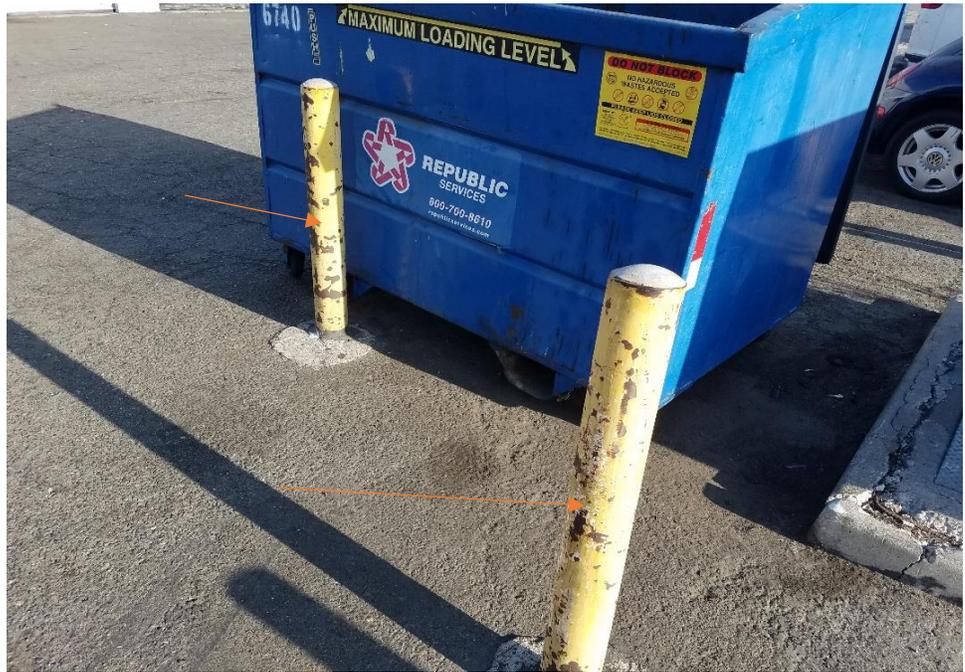
Table 3 – Lead Results Summary						
Room/Area	Component	Substrate	Condition	Color	Approximate Quantity	Photograph No.
<b>Exterior</b>						
Exterior	Bollard	Metal	Poor	Yellow	12 each	5
Exterior	Sewer grate	Metal	Poor	Gray	1 SF	6
<b>1514 West Lincoln Avenue</b>						
NA						
<b>1516 West Lincoln Avenue</b>						
Office, Restroom	Floor tile	Ceramic	Intact	White	123 SF	7
Office, Restroom	Baseboard	Ceramic	Intact	White	25 LF	7
Office and Break Room	Crown molding	Wood	Intact	White	100 LF	8
<b>1518 West Lincoln Avenue</b>						
NA						
<b>1520 West Lincoln Avenue</b>						
NA						
<b>Notes:</b>						
LF – linear feet						
NA – not applicable						
No. – number						
SF – square feet

**Photograph 5:** View of the lead-containing paint on bollards with paint in a poor condition.

- The identified LCSs should not be disturbed. The lead containing ceramic tile removal activities should be performed by a licensed abatement contractor with certified lead personnel. The exterior paint in the non-intact condition (bollard and sewer gate) should be stabilized and the substrate should be encapsulated. All lead related removal activities should be performed in accordance with the DOSH Lead in Construction Standard, Title 8 California Code of Regulations (CCR) 1532.1.

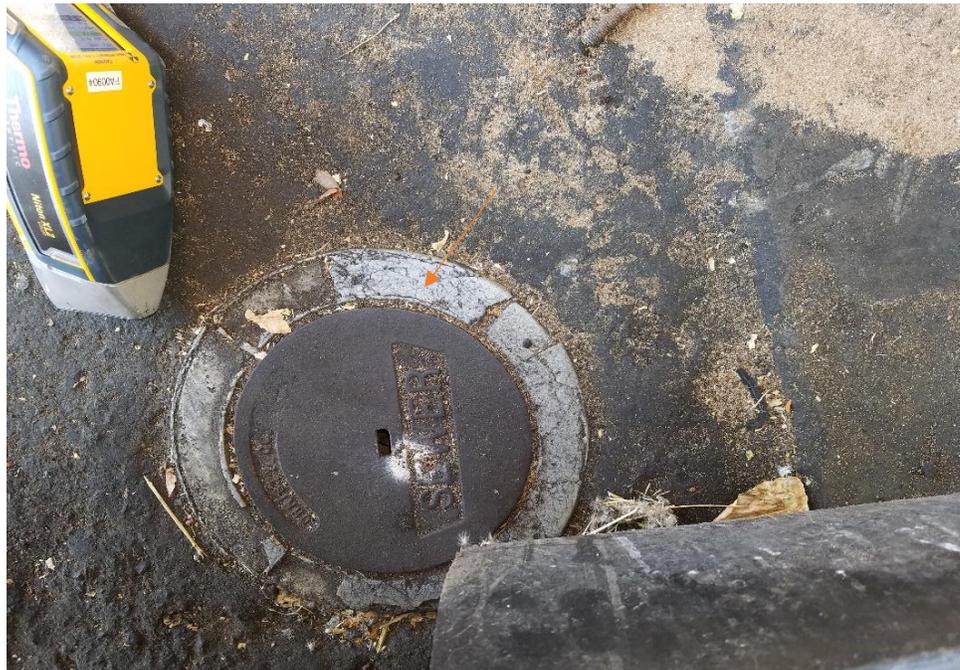
**Photograph 6:** View of the lead-containing paint sewer grate in a poor condition.

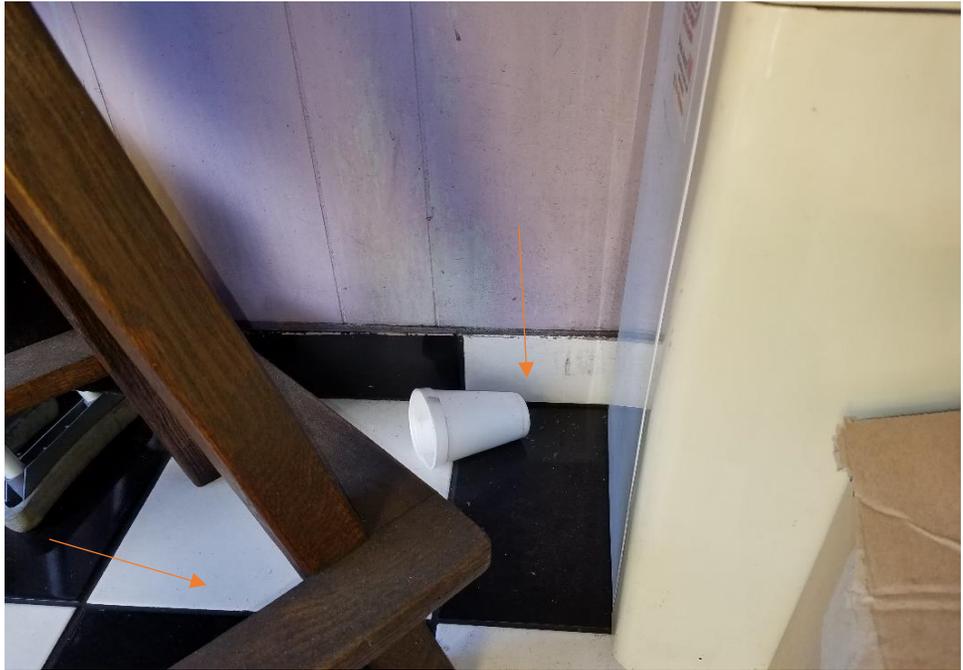
**Photograph 7:** View of the lead-containing white ceramic wall tile and baseboard in Unit 1516 office.

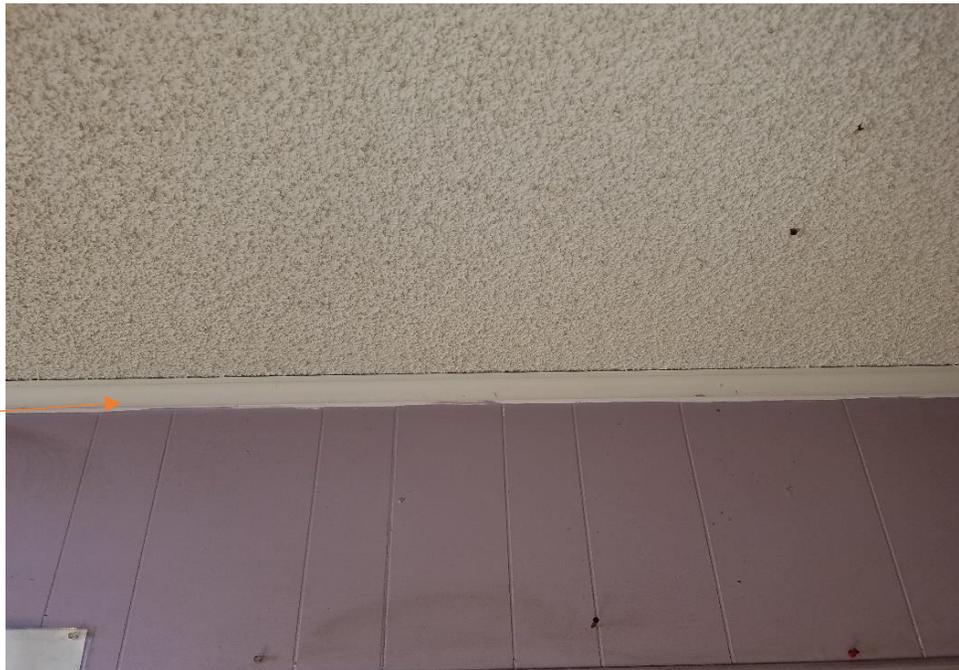
**Photograph 8:** View of the lead-containing white wood crown molding in Unit 1516 office and break room.

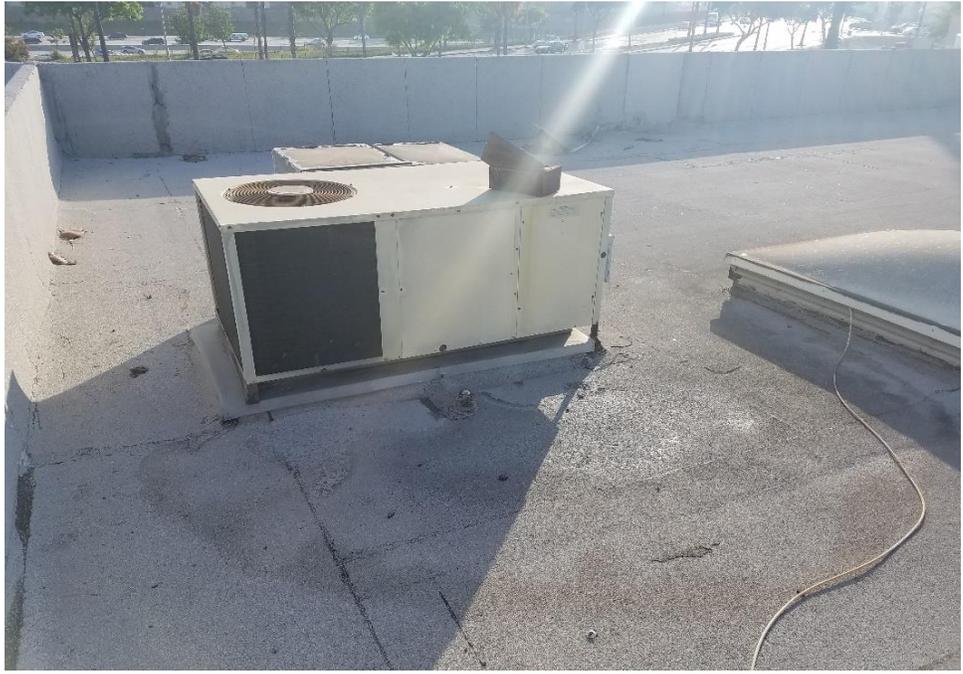
**Photograph 9: View of exterior rooftop HVAC units.**

- Universal wastes discussed in this report (Table 4), should be removed and properly recycled or disposed by the licensed abatement contractor prior to renovation activities. Contractor should provide proper manifesting for all hazardous materials removed and recycled to prove the disposal of all materials was completed in accordance with local, state, and federal requirements.

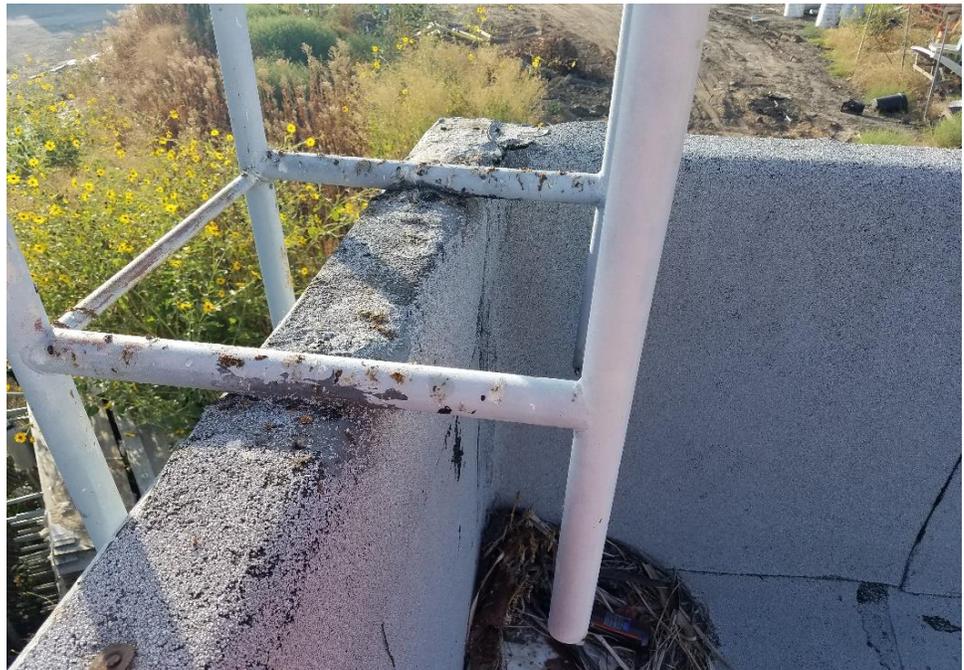
**Photograph 10: View of bird droppings at exterior roof access ladder.**

- If demolition plans change to renovations for re-occupancy the following universal wastes (bird droppings at exterior ladder; and water stained ceiling in Unit 1514) will require additional investigation in order to develop recommendations for remediation.

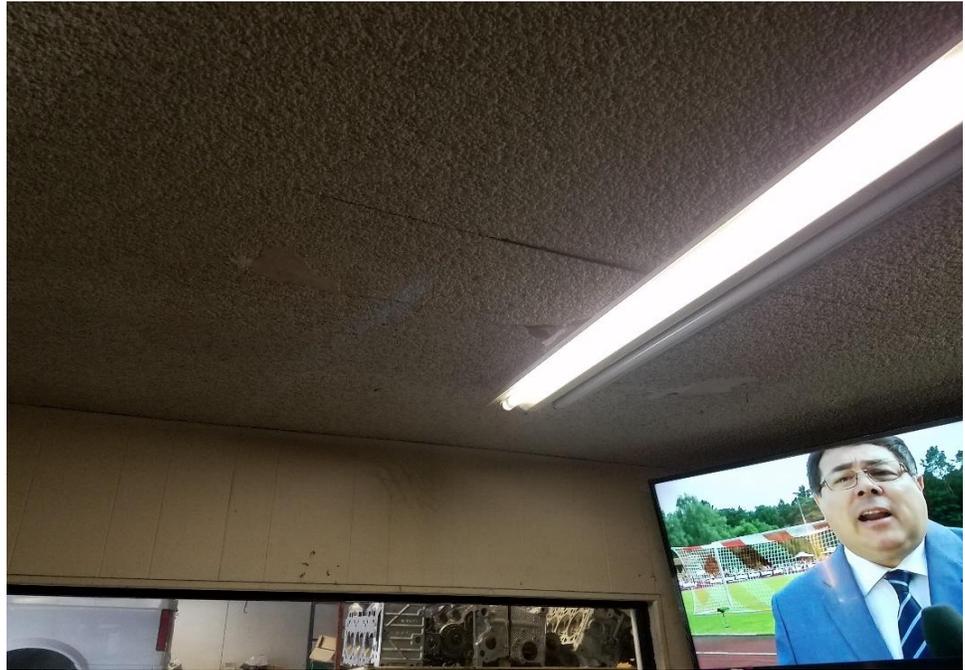
**Photograph 11:** View of representative fluorescent lights and ballasts.

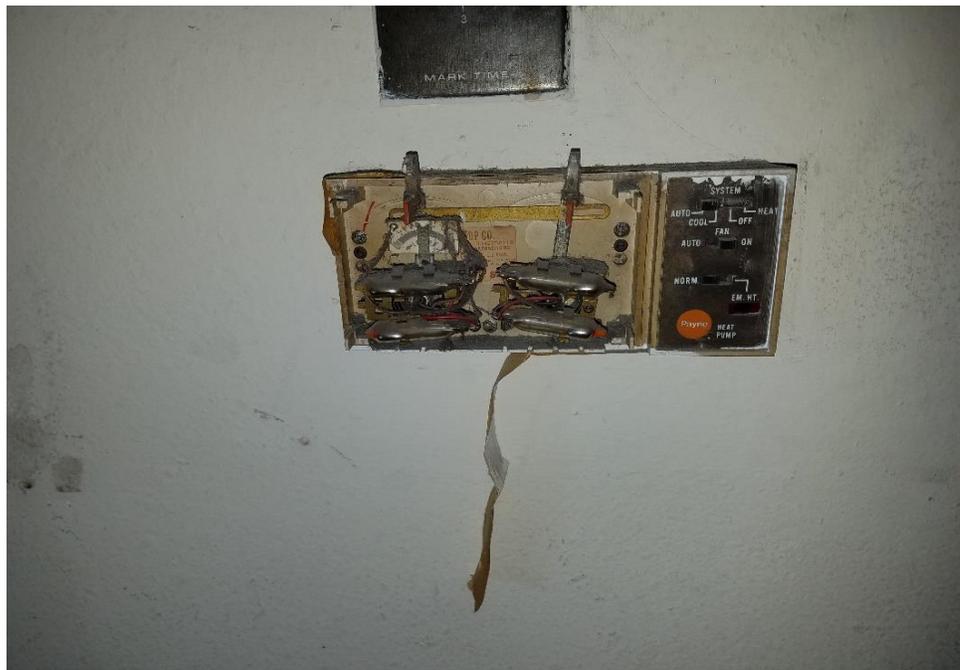
**Photograph 12:** View of representative mercury-containing thermostat switches.

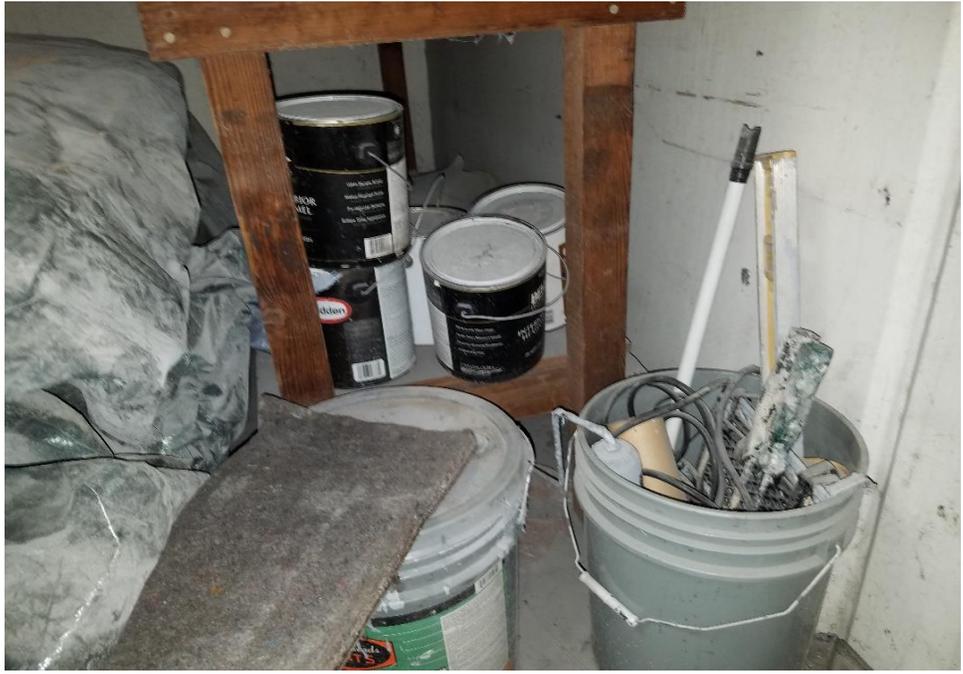
**Photograph 13:** View of paint cans.

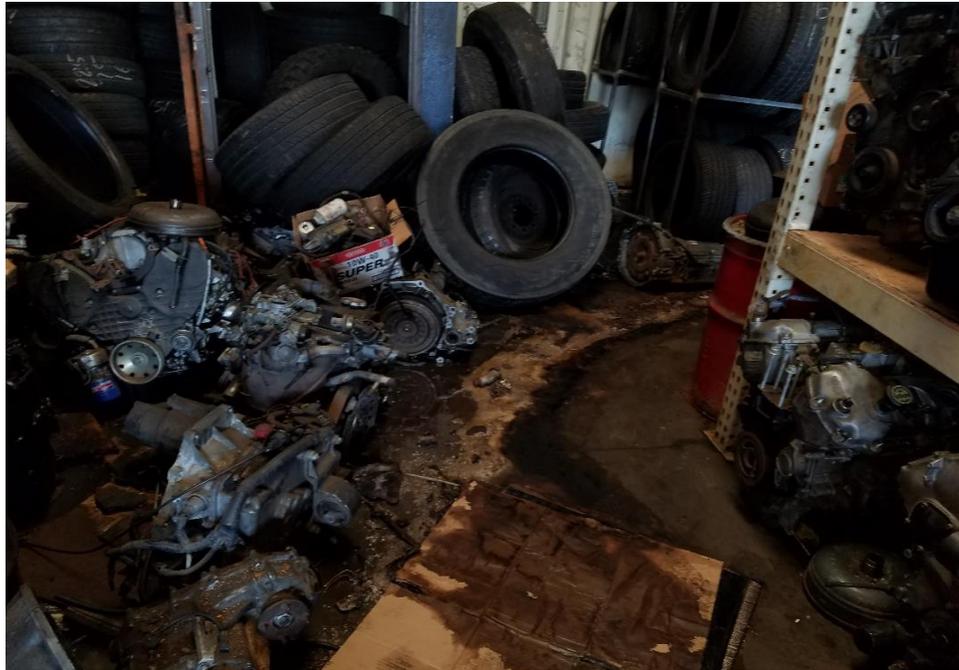
**Photograph 14:** View of oil staining located in Unit 1514.

- The oil staining and light ponding observed at the flooring area within Unit 1514 should be cleaned up and waste characterized for appropriate disposal. Once the oil has been cleaned, the concrete should be observed for cracks. If cracks in the concrete are present, limited soil sampling (boring) should be performed to confirm that petroleum hydrocarbons have not penetrated to the subsurface.
- Monitoring consulting services should be performed by a third party environmental consultant, to ensure the appropriate removal of the hazardous materials prior to building demolition activities.

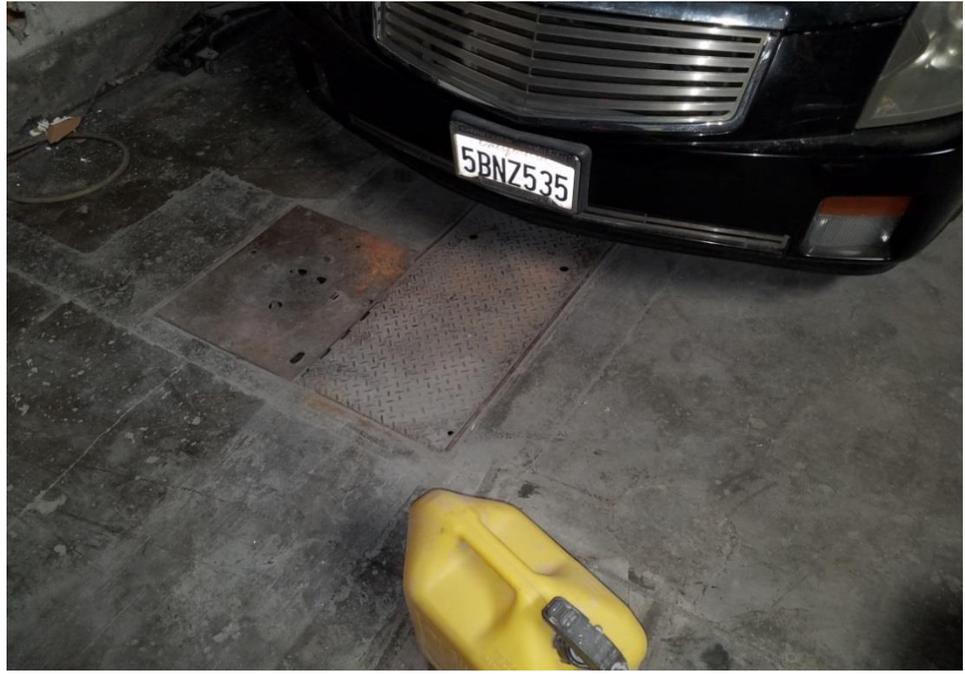
**Photograph 15:** View of either oil pit or clarifier located in Unit 1514.

- The oil pit/clarifier observed in Unit 1514 may contain liquids and should be emptied prior to building demolition. The liquid should be waste characterized for appropriate disposal. Limited soil sampling (borings) should be performed at two locations, one on each end of the waste oil pit/clarifier to confirm that petroleum hydrocarbons have not penetrated to the subsurface.
