LAGUNA NIGUEL TO SAN JUAN CAPISTRANO PASSING SIDING PROJECT

INITIAL SITE ASSESSMENT

DRAFT TECHNICAL MEMORANDUM

January 2013

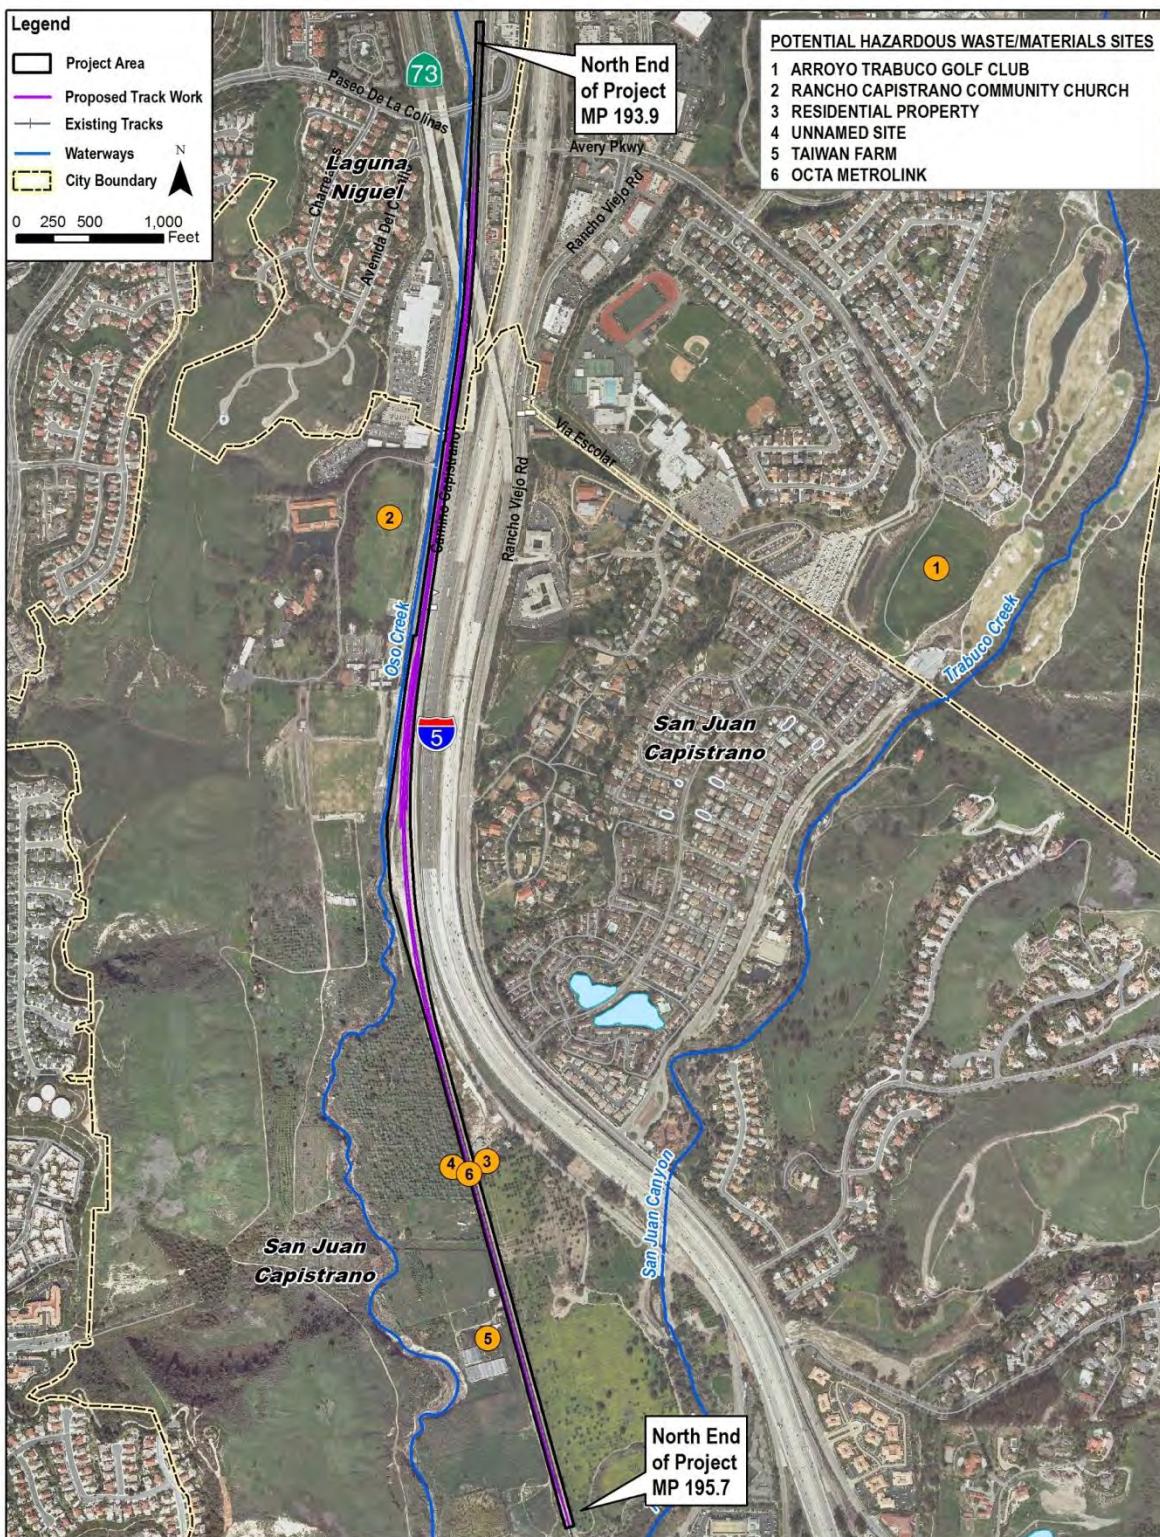
Figure 4-1: Potential Hazardous Waste/Materials Sites

Based on a visual assessment during the site reconnaissance, additional potential hazardous waste sites, which did not appear in the EDR database, were identified. This visual assessment was conducted approximately 300 feet north, east, west, and south of the project boundary. These sites are located within and adjacent to the project boundary and are presented in Table 4-3. All of the sites that were investigated during the site reconnaissance are shown in Figure 4-1.

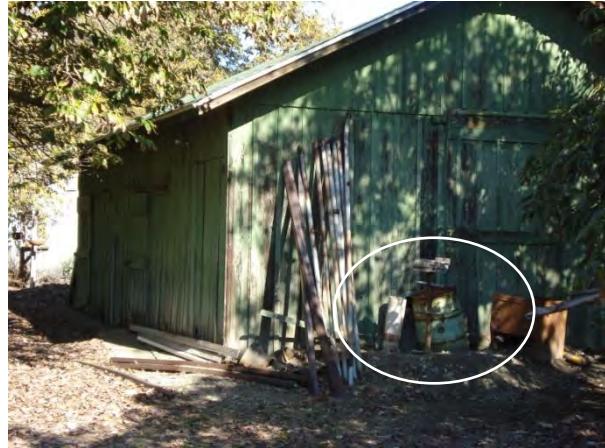
Photo 3B – Residential Property (29931 Camino Capistrano, San Juan Capistrano). An additional 55-gallon metal rusted drum was noted. The drum was missing a lid and was unlabeled.

Status: No site records were available for this site. However, during site reconnaissance, four unlabeled 55-gallon metal rusted drums, including one drum with a missing lid, were noted to be stored behind the residential property and near a tool shed. Although there may be a potential for hazardous waste/materials to be stored on site, construction of the proposed project is not anticipated to affect the 55-gallon metal drums. As a result, this site does not pose an environmental concern to the proposed project.

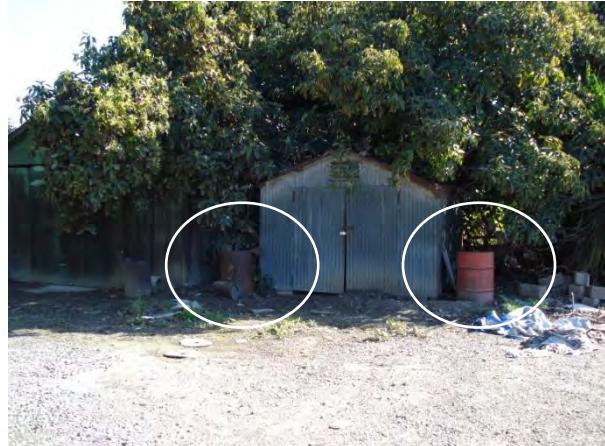
Photo 3C – Residential Property (29931 Camino Capistrano, San Juan Capistrano). Two additional 55-gallon metal rusted drums were noted to be stored near a tool shed.

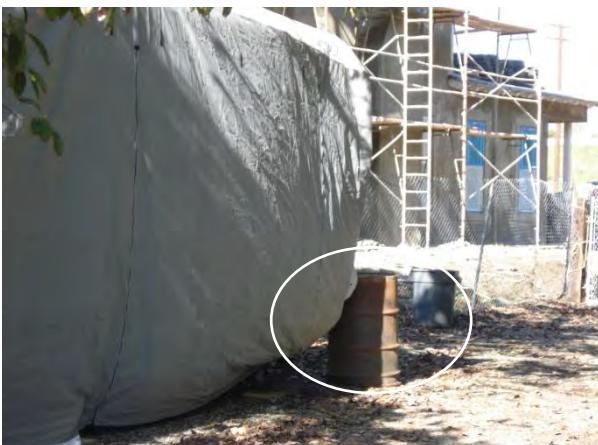
Photo 3A – Residential Property (29931 Camino Capistrano, San Juan Capistrano). This site is to a residential property. An unlabeled 55-gallon metal rusted drum was noted.

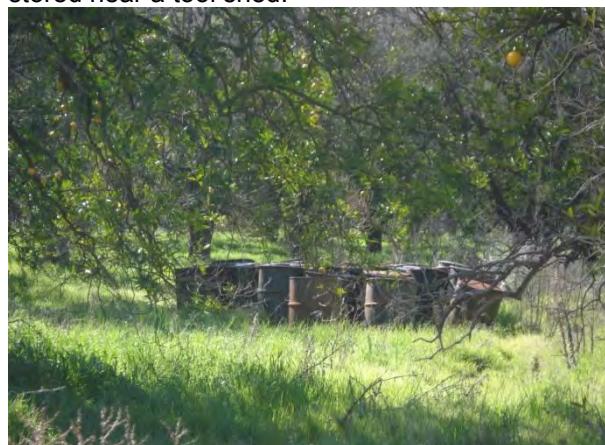
Photo 4A – Unnamed Site (APN 637-082-14). This site is primarily open space. Multiple 55-gallon metal rusted drums appear to have been abandoned on this site.

Status: No site records were available for this site. However, during site reconnaissance, approximately 37 unlabeled 55-gallon metal rusted drums were noted onsite and appeared to have been abandoned. Multiple drums had open nozzle caps on the lids, with a resonating odor of petroleum or asphalt. In addition, a dumping ground consisting of automobiles, trash, debris,

- Unnamed Site (APN 637-082-14, San Juan Capistrano) – During site reconnaissance, approximately 37 unlabeled 55-gallon metal rusted drums were noted and appeared to have been abandoned. Multiple drums had open nozzle caps on the lids with a resonating odor of petroleum or asphalt. In addition, a dumping ground consisting of automobiles, trash, debris, and seven abandoned 55-gallon metal rusted drums was observed at the southern end of the parcel. Although the 55-gallon metal drums are not located within the disturbance limits of the proposed project, given the close proximity of the drums and the odor resonating from the drums, it is possible that hazardous waste/materials have spilled or leaked from the drums and migrated onto the disturbance area. A Phase II ESA should be performed prior to any ground disturbing activity to determine if contamination from this site may have migrated into the area proposed for construction disturbance.

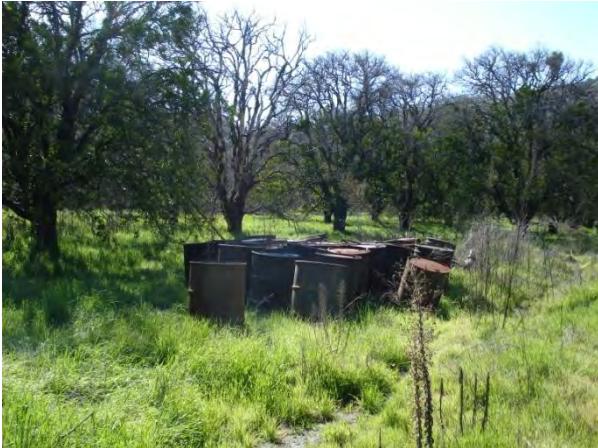
Photo 4B – Unnamed Site (APN 637-082-14). A number of the drums had open nozzle caps on the lids. A resonating odor of petroleum or asphalt was also noted.

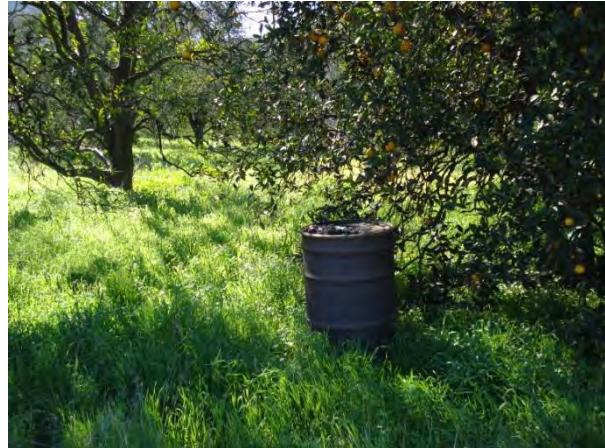
Photo 4E – Unnamed Site (APN 637-082-14). An additional unlabeled 55-gallon metal rusted drum was noted at the southern end of the parcel.

and seven abandoned 55-gallon metal rusted drums, was observed at the southern end of the parcel. Although the 55-gallon metal drums are not located within the disturbance limits of the proposed project, given the close proximity of the drums and the odor resonating from them, there is the potential that hazardous waste/materials may have spilled or leaked from the drums and migrated onto the proposed project site. A Phase II ESA should be performed for this site to determine if any site contamination may have migrated onto the proposed project site. Findings from the Phase II ESA will determine the appropriate handling and disposal of any contaminated soils.

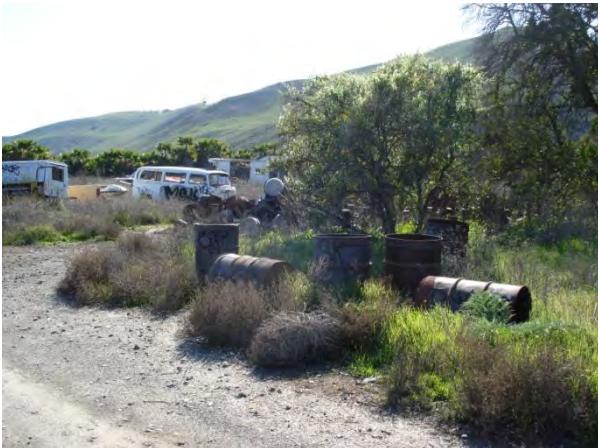
Photo 4C – Unnamed Site (APN 637-082-14). A dumping ground consisting of automobiles and multiple 55-gallon metal rusted drums was noted to at the southern end of the parcel. The drums were unlabeled, had no lids, and appear to have been abandoned.

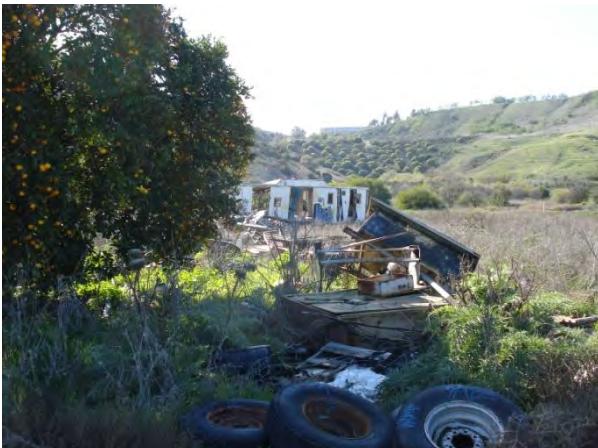
Photo 4D – Unnamed Site (APN 637-082-14). Trash and debris were also noted at the dumping ground.

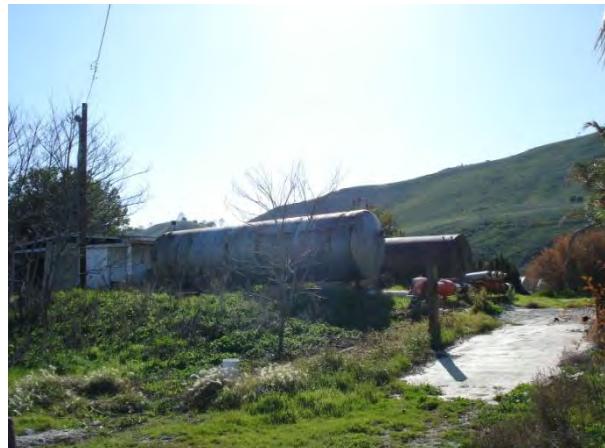
Photo 5B – Taiwan Farm (APN 121-050-12). Two large ASTs containing water were noted to be stored on site.

Status: No site records were available for this site. However, during site reconnaissance, two large and two small ASTs were noted to be stored on site. A worker on the property stated the large ASTs contained only water. The small ASTs looked to be propane tanks and did not appear to be active. The ASTs do not appear to contain any hazardous waste/materials, and construction of the proposed project is not anticipated to affect these ASTs. As a result, the ASTs do not pose a potential contamination risk and this site does not pose an environmental concern to the proposed project.

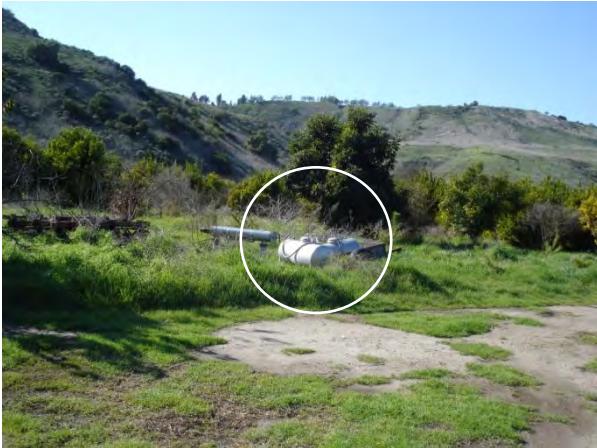
Photo 5C – Taiwan Farm (APN 121-050-12). Two small ASTs were also noted to be stored on site. The ASTs appear to be propane tanks and do not pose a potential contamination risk to the project. These small ASTs did not appear to be active.

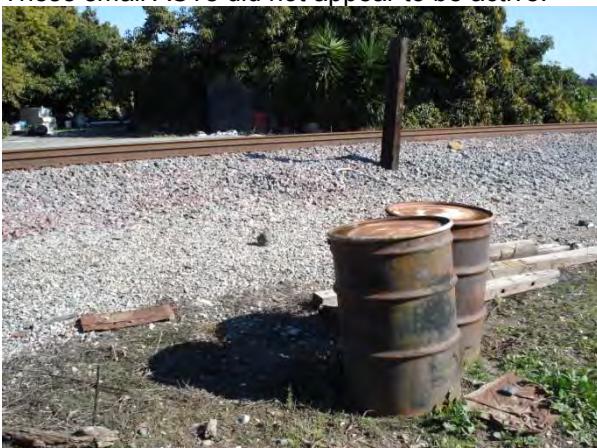
Photo 6 – OCTA Metrolink (approximately 50 feet southwest of 29931 Camino Capistrano, San Juan Capistrano). Two 55-gallon metal rusted drums were noted within the disturbance limits of the proposed project (west of the railroad tracks). Both drums were unlabeled and appeared abandoned.

Status: No site records were available for this site. However, during site reconnaissance, two unlabeled 55-gallon metal rusted drums were observed to be located within the disturbance limits of the proposed project (west of the railroad tracks) and, as a result, construction of the proposed project may affect these two drums. Both drums appeared to have been abandoned. It is unknown if the drums contain any hazardous waste/materials. A Phase II ESA should be performed to characterize the content stored in the drums, and to assess for any possible soil contamination that may have resulted from a leak beneath the drums. Findings from the Phase II ESA will determine the appropriate handling and disposal of the drums and potentially contaminated soils.

- OCTA Metrolink (approximately 50 feet west of 29931 Camino Capistrano, San Juan Capistrano) – During site reconnaissance, two unlabeled 55-gallon metal rusted drums were observed within the disturbance limits of the proposed project (west of the railroad tracks); project construction may affect these two drums. There is also a potential for encountering contaminated soil that may have resulted from a leak beneath the drums. Both drums appeared to have been abandoned, and it is not known if the drums contain any hazardous waste/materials. A Phase II ESA should be performed prior to any ground

disturbing activity to characterize the contents of the drums and to assess the potential for soil contamination that may have resulted from a leak beneath the drums.
