**Orange County
Transportation Authority**

**Site Selection & Master Planning
For The
Transit Security & Operations Center (TSOC)**

**Existing Facility Assessment
& Need for Relocation - Final**

June 19, 2013 - Draft
September 11, 2013 – Final

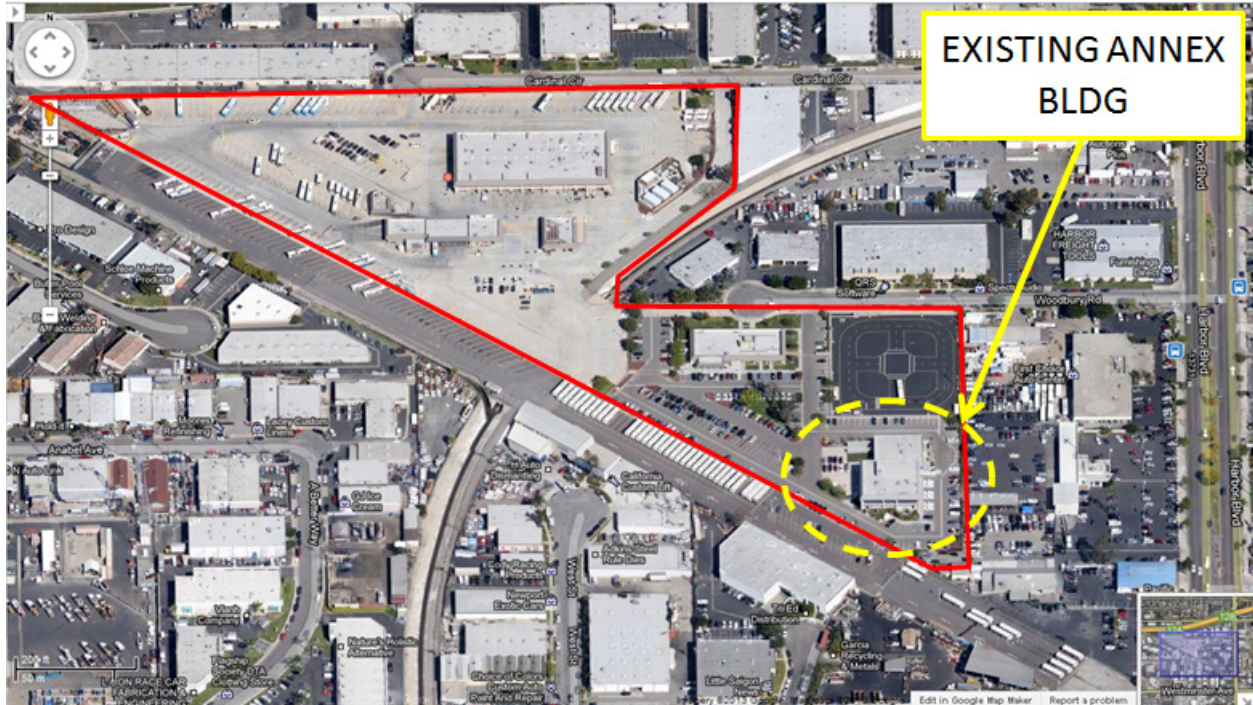
Aerial image of Garden Grove Base

The Annex is located on the same site as the Garden Grove Maintenance Facility, the Bus Operations Building, and the Operator Training Course.

- A flood control channel intersects the site and has become a byway for vagrants and teenagers. OCTA Security and Sheriff’s staff indicated past issues with trespassers entering the OCTA site from the flood control channel. A new site without such a flood control channel would eliminate this adjacent byway and lessen trespassing events in this regard.
- The OCTA Security and Sheriff’s staff indicated that the adjacent automotive repair, industrial, and salvage properties may employ a workforce that is not conducive to the location of a secured operations center or Sheriff’s station. Several of these adjoining properties have direct visual access to the Sheriff’s parking area which is not preferred.
- The back-up generator and fuel tank are located in the parking lot. It is suggested that they are located within a secured area to avoid tampering and vandalism.
