COASTAL RAIL EMERGENCY PROJECTS

Crews Complete Riprap Placement in Project Areas 1 and 2

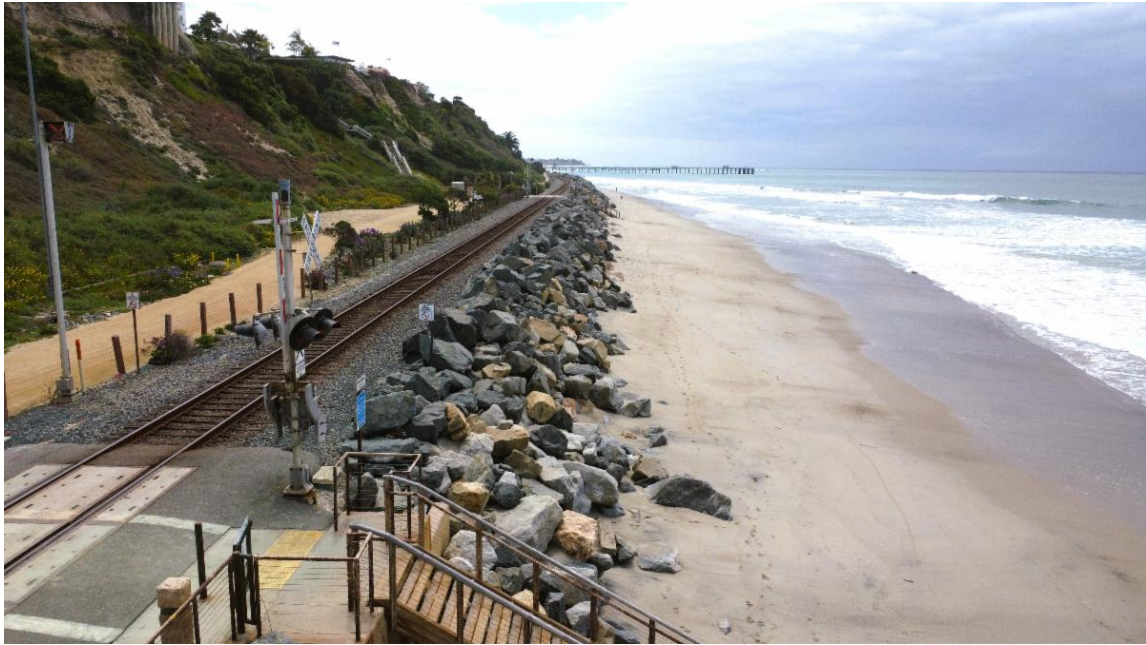
Before Photo: Riprap conditions near El Portal beach access

Crews have also completed the strategic placement of large boulders, known as riprap, in Project Areas 1 and 2 to protect the railroad track from ongoing coastal erosion.

In total, approximately 5,900 tons of riprap were installed—more than 1,700 tons less than the original construction estimate of 7,650 tons. This reduction was achieved through efficient use and reorganization of existing riprap, allowing the project team to reinforce the track using less new material while still meeting safety and stabilization goals.

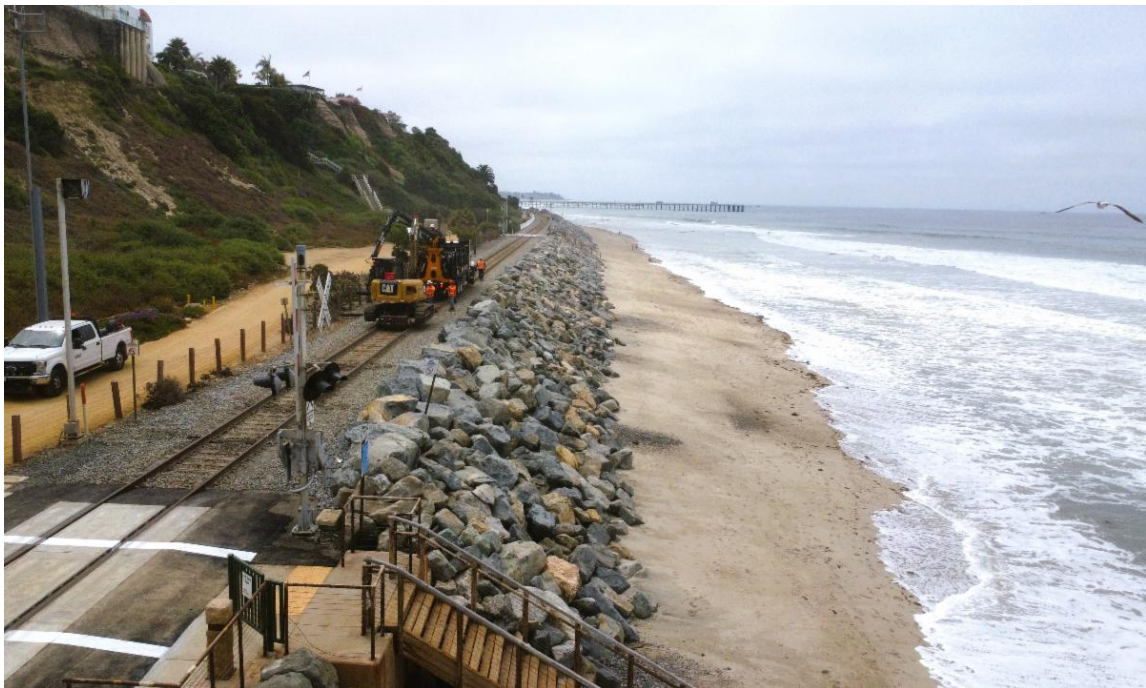
After Photo: Final riprap conditions near El Portal beach access

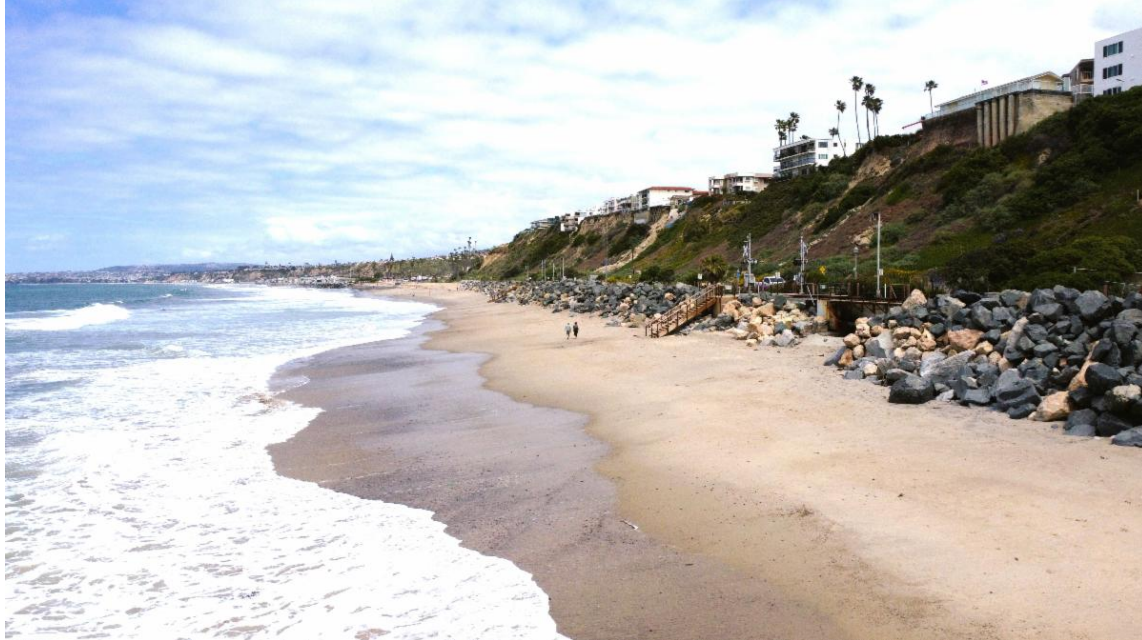
Before Photo: Riprap conditions near Dije Court beach access

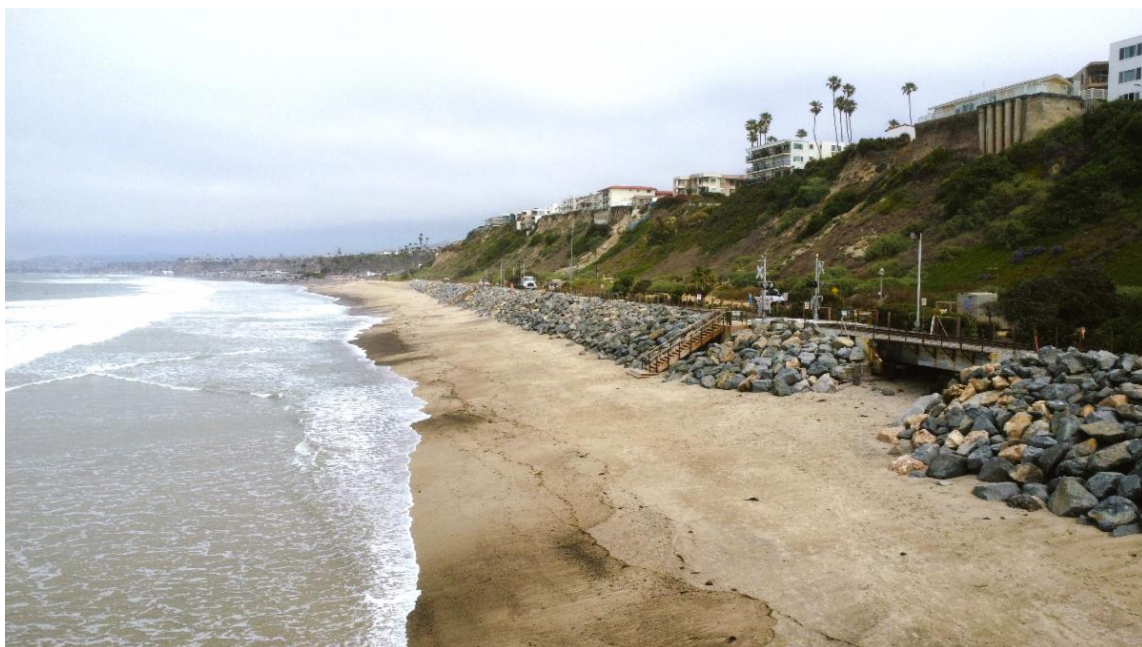
After Photo: Riprap conditions near Dije Court beach access
